# Manhole Inspection Summary

Manhole # S43GG\_031MH

Insp Date: **7/2/09 12:49 PM**

**Location** Address: **BEHIND 1800 BIDDLE ST**

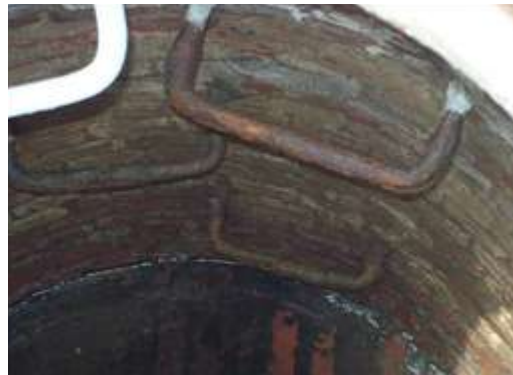
Defect 2

**Steps** Count: **4** Missing: **0** ☒ **Corroded**

corroded steps

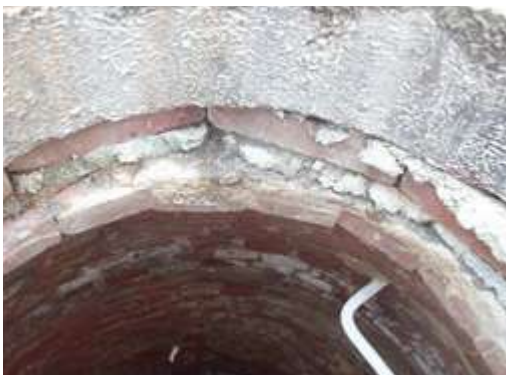
Defect 1

Condition: ☐ Sound ☒ **Cracked** ☐ Root Intrusion ☒ **Loose Brick** ☐ Deteriorated

cracked cover, loose bricks

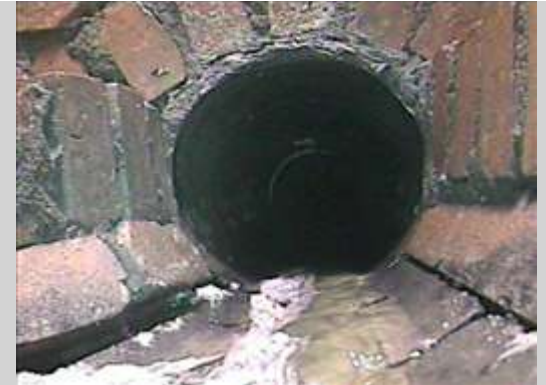
12 O'Clock Outflow

8 in. Circular Gravity Sewer  
Pipe Out @ 12 O'Clock

Invert Depth: **8.15** (ft.) Flow Characteristics: **Slow**

Infiltration: **None** Pipe Seal Cond: **Sound**

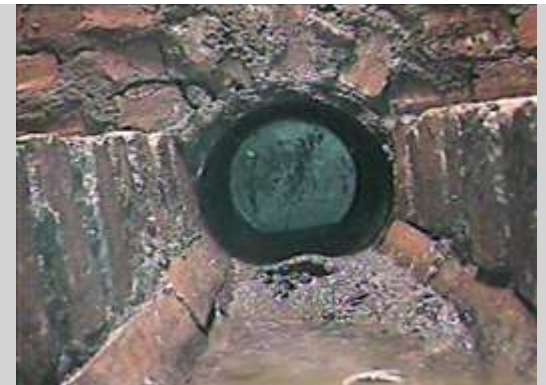
6 O'Clock Inflow

8 in. Circular Gravity Sewer  
Pipe In @ 6 O'Clock

Invert Depth: **8.18** (ft.) Flow Characteristics: **Slow**

Infiltration: **None** Pipe Seal Cond: **Sound**

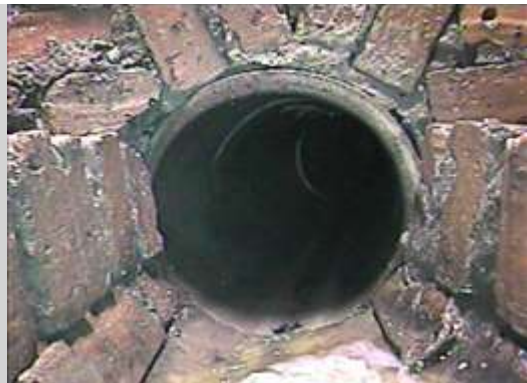
9 O'Clock Inflow

8 in. Circular Gravity Sewer

Pipe In @ 9 O'Clock

Invert Depth: **8.10** (ft.) Flow Characteristics: **Slow**

Infiltration: **None** Pipe Seal Cond: **Sound**
